M 5.6, 104km SW of Ocos, Guatemala

Origin Time: 2020-02-02 03:32:44 UTC (Sat 21:32:44 local)

Location: 13.8010° N 92.8294° W Depth: 10.0 km

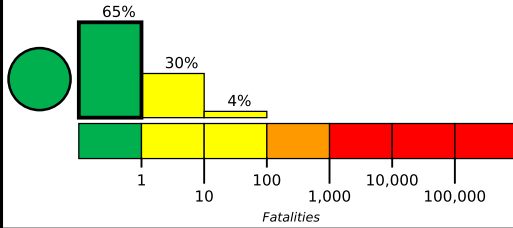
Estimated Fatalities

Green alert for shaking-related fatalities and economic losses. There is a low likelihood of casualties and damage.
